**NASA Technical Memorandum 84533** NASA-TM-84533 19820025857

RESULTS FROM TESTS OF THREE PROTOTYPE GENERAL AVIATION SEATS

M. SUSAN WILLIAMS  
EDWIN L. FASANELLA

AUGUST 1982

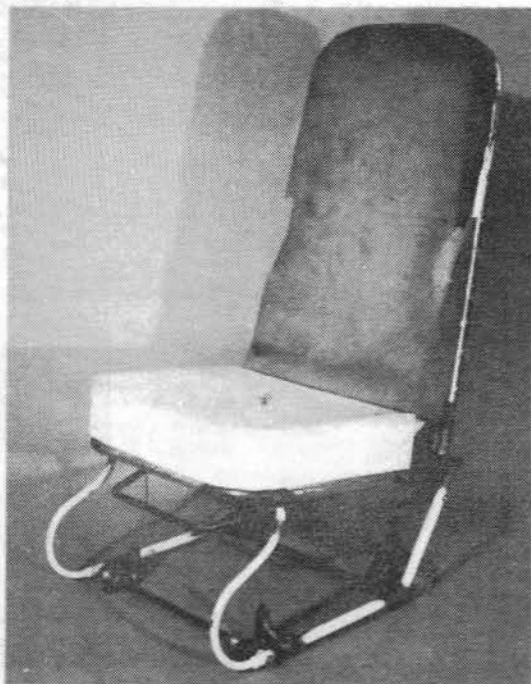
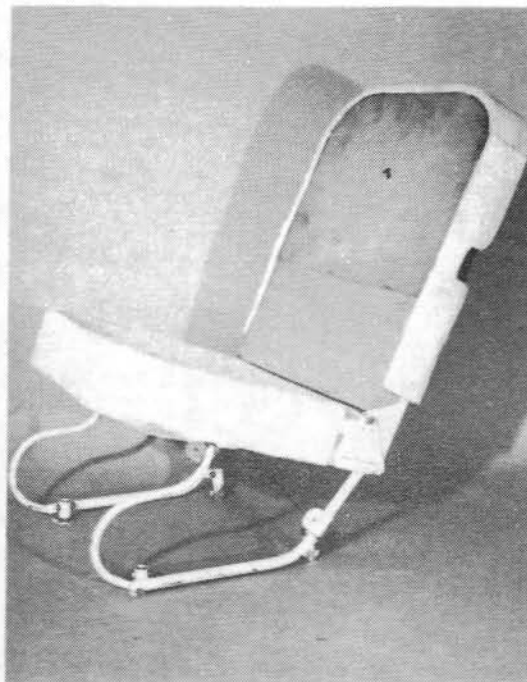
Figure 1.- JAARS seats.

CREW SEAT

FOLDING PASSENGER SEAT

FOAM BLOCK PASSENGER SEAT

The three prototype general aviation aircraft seats, supplied by JAARS for testing at NASA Langley Research Center, are shown in figure 1 and consisted of a crew seat, a folding passenger seat, and a foam block passenger seat. Both the crew seat and the folding passenger seat were constructed of 4130 tubular steel and incorporated S-shaped front legs that were designed to form plastic hinges to limit the load and provide energy absorption (ref. 1). The cushion of the foam block passenger seat was composed of various-density foam layers.

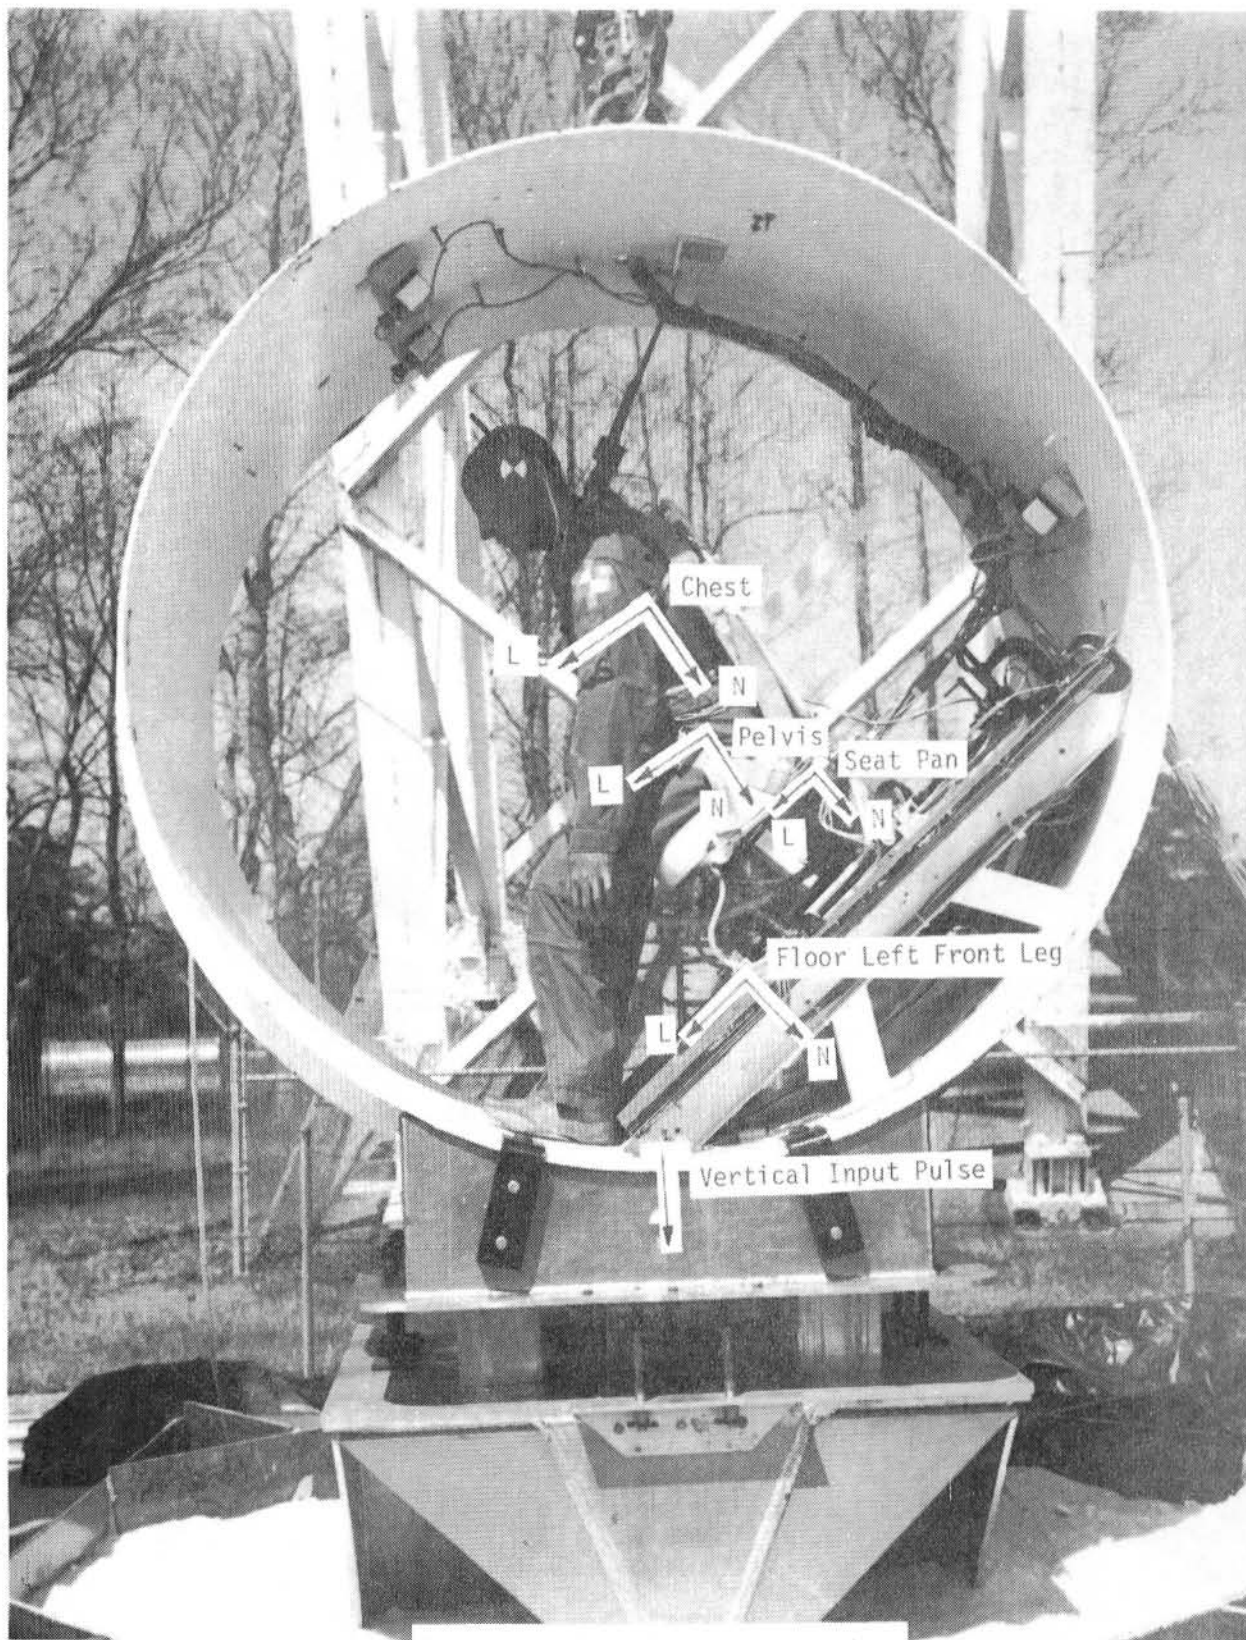
Figure 4.- Dynamic test apparatus.

DC accelerometers were used in the dummy, on the seat, and on the floor to obtain a continuous recording of the accelerations during the dynamic tests. Figure 4 is a close-up view of the dynamic test apparatus and shows positive acceleration directions. Load cells were used on the shoulder harness and lap belt to record the tension in the straps. Extensometers were installed on the seat to monitor normal and longitudinal seat displacements. All data were transmitted to a tape recorder through an umbilical cord that was hard-wired to the instrumentation system.

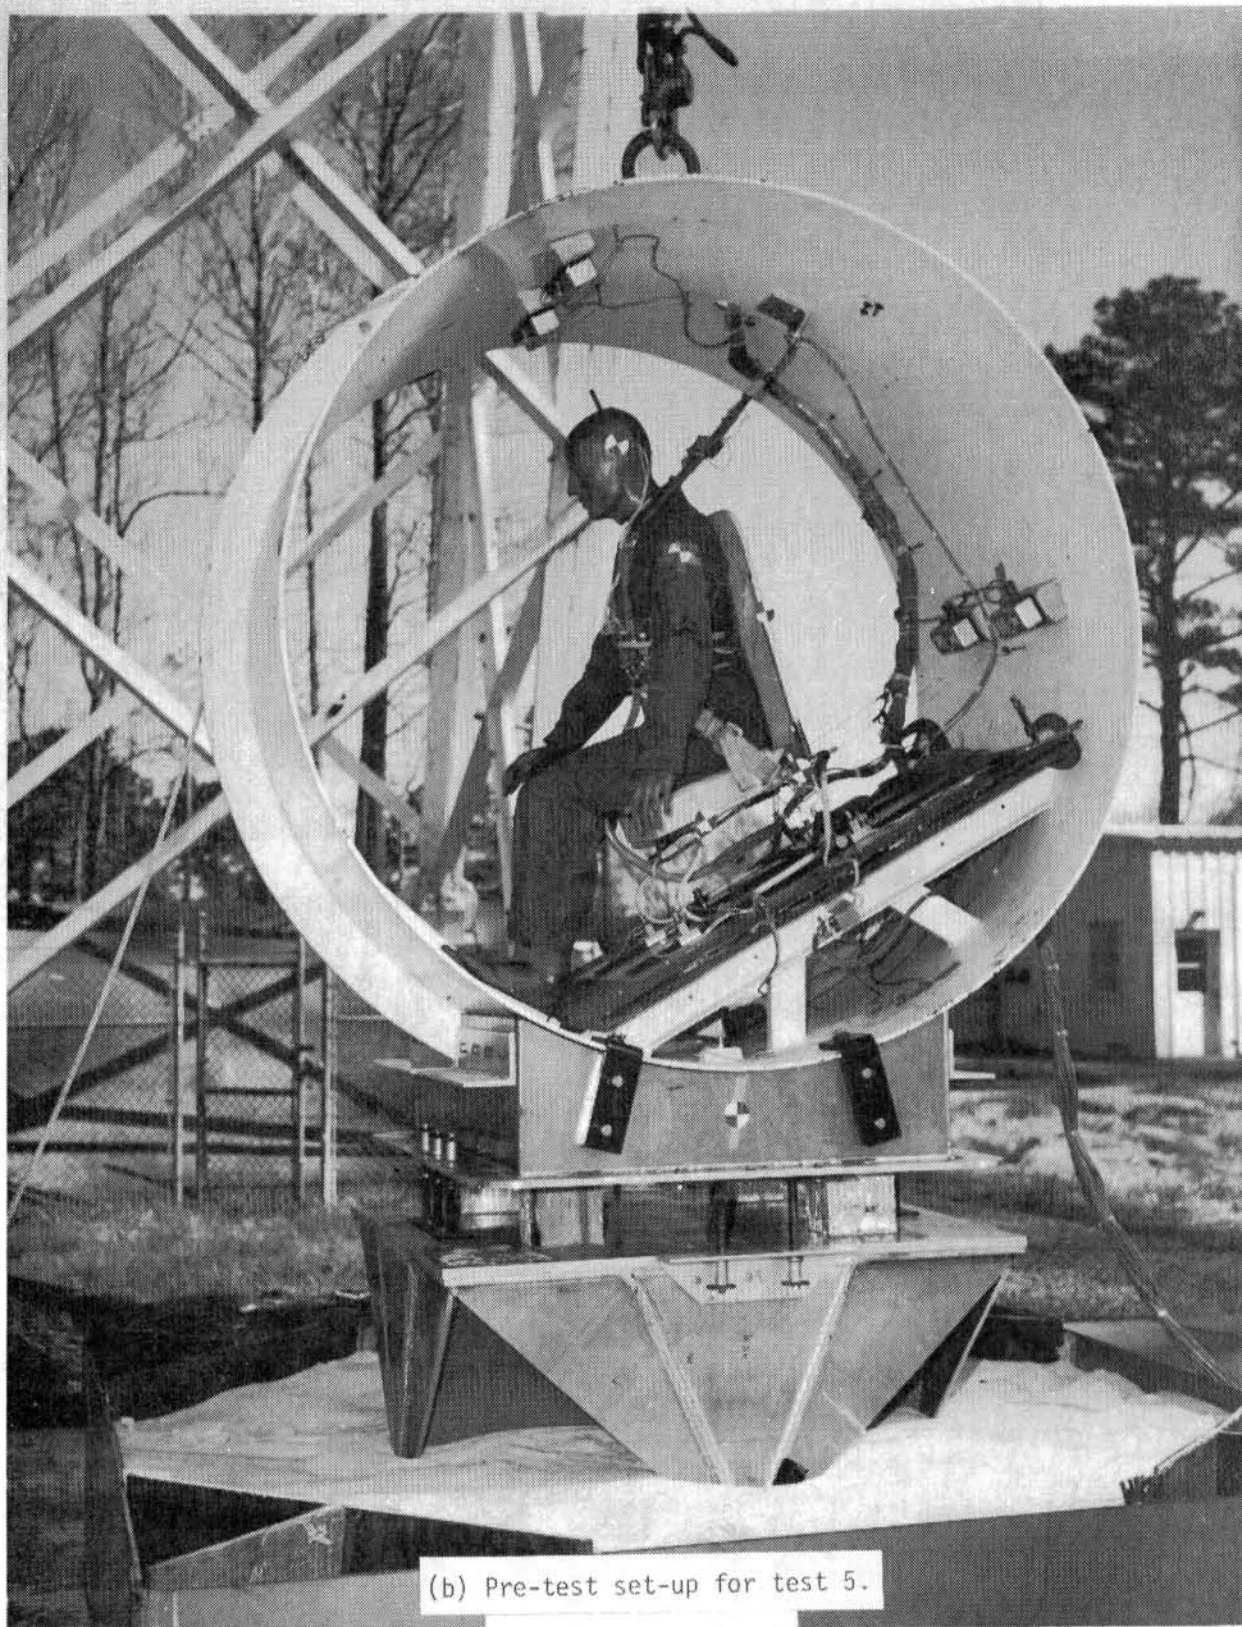
(b) Pre-test set-up for test 5.

JAARS Crew Seat. - Figures 5(a) through 5(e) show pre-test and post-test photographs of the JAARS crew seat for tests 1 and 5. Figures 5(a) and 5(b) show the test set-up (impact position) for the 42° pitch down condition (test 1) and 30° pitch down condition (test 5), respectively. For each test, the seat height adjustment was set in the intermediate notch; the lowest notch setting could not be used because of interference between the seat and the seat rail. The seat back adjustment was also set in the intermediate notch because another interference prevented the seat back from being positioned in the most reclined position.

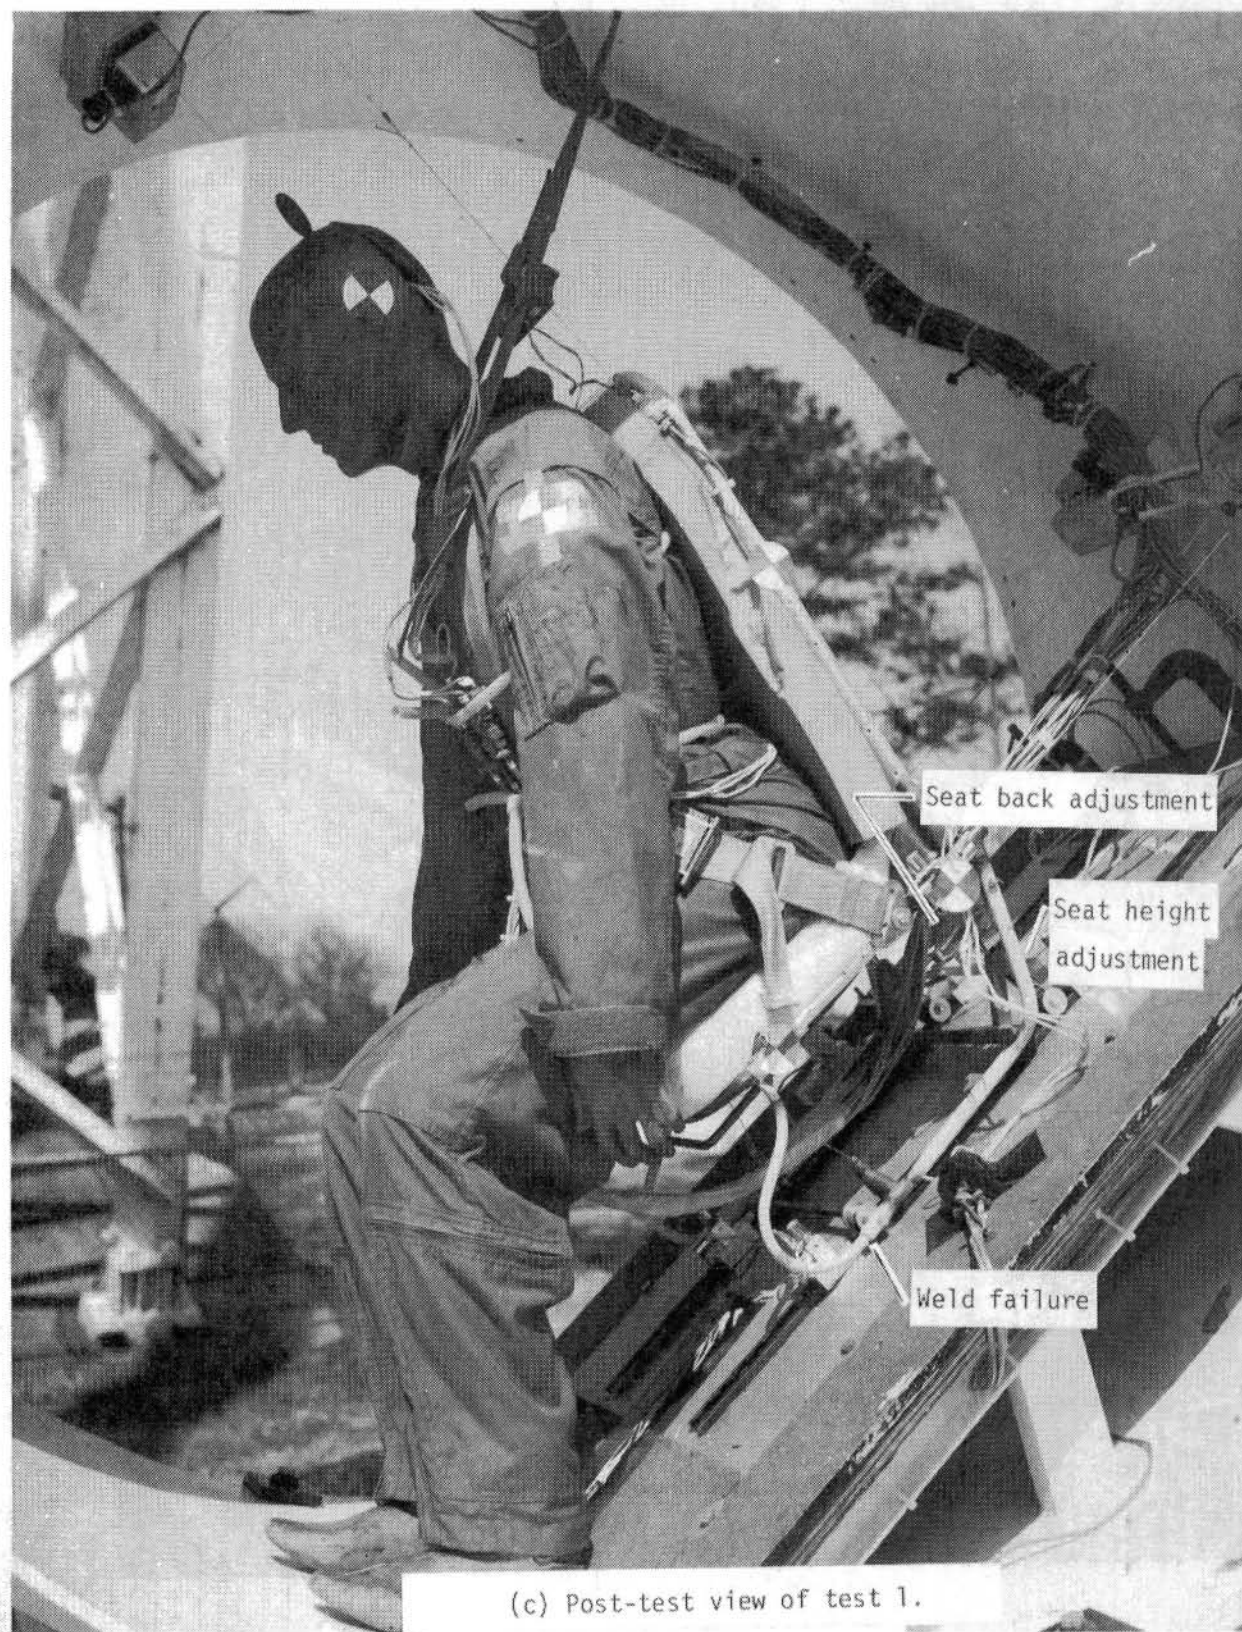
(c) Post-test view of test 1.

Figures 5(c) and 5(d) present post-test photographs of test 1 and test 5, respectively. Extensometer data from test 1 indicated a maximum seat displacement of approximately 1 inch during impact in both the normal and longitudinal directions. However, post-test measurements showed that the seat was permanently deformed less than 0.5 inch in either direction. Extensometer data from test 5 indicated negligible displacements, which were confirmed by post-test measurements.

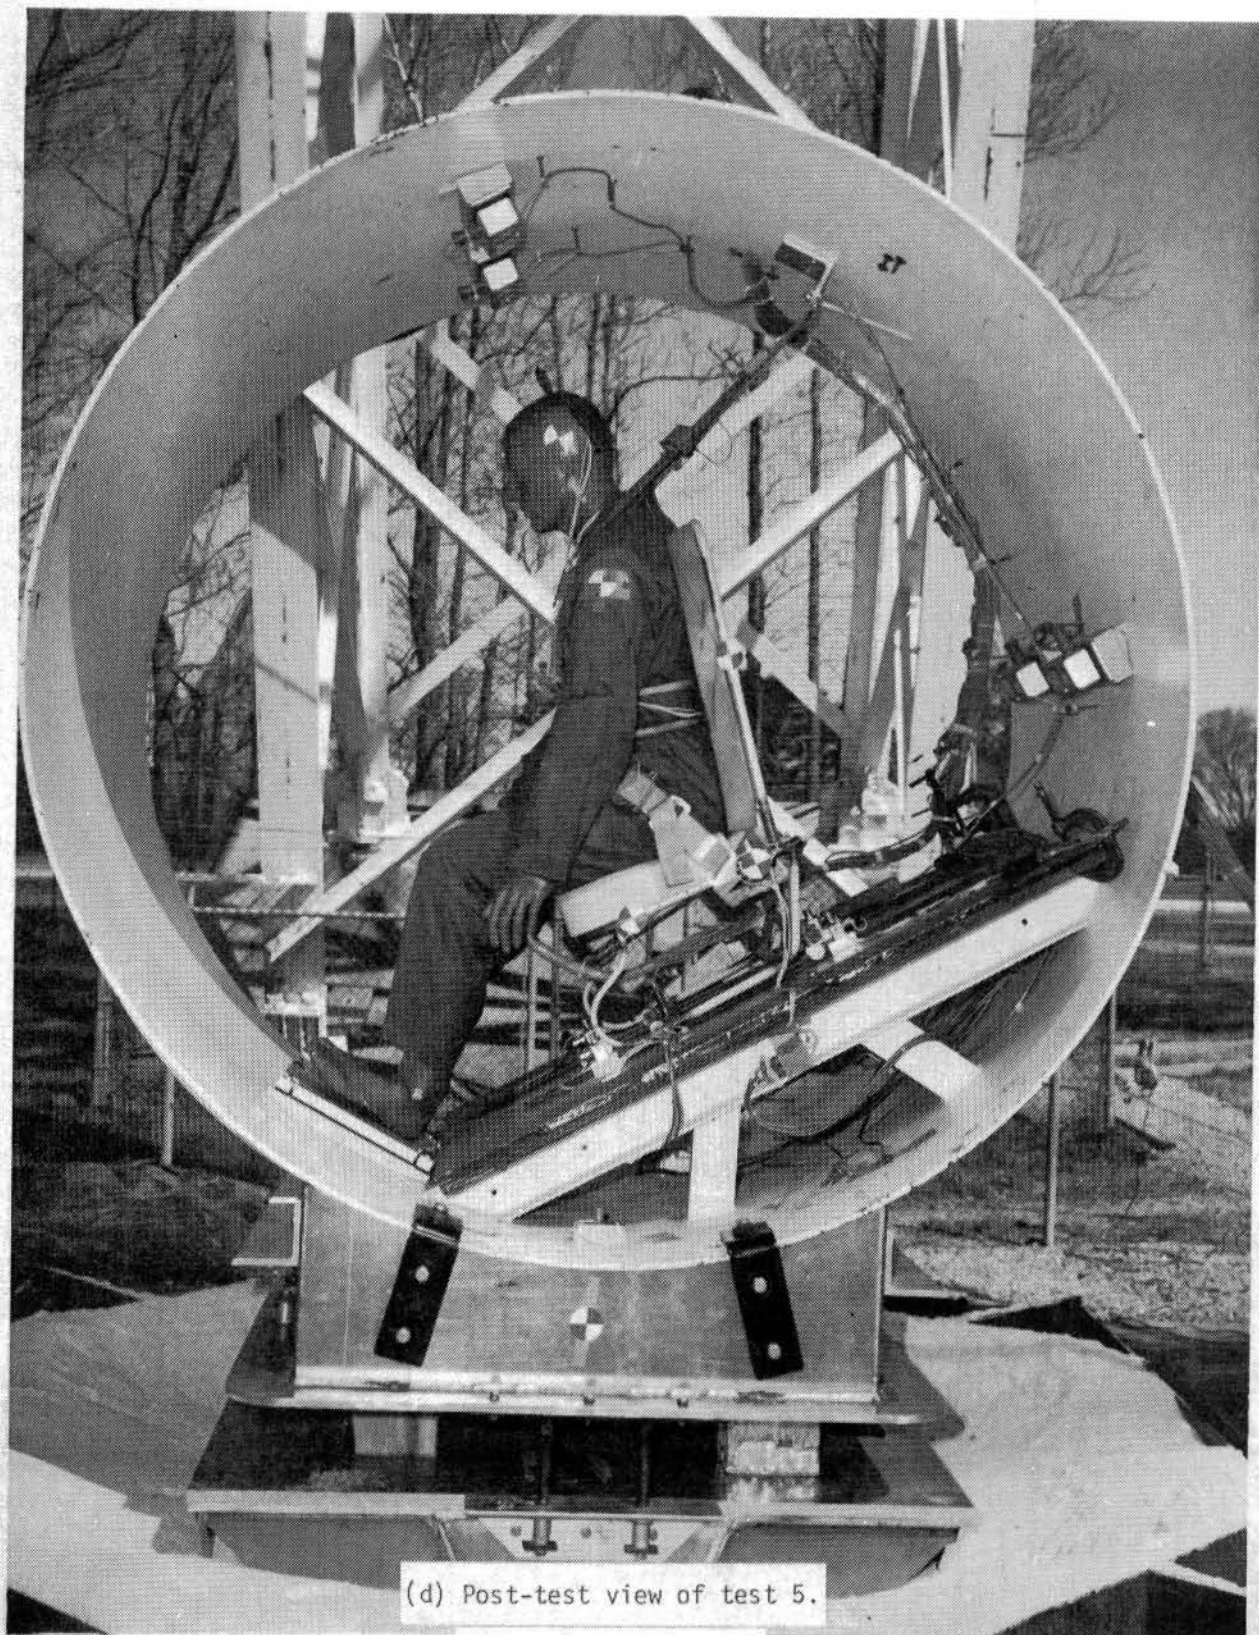
(d) Post-test view of test 5.

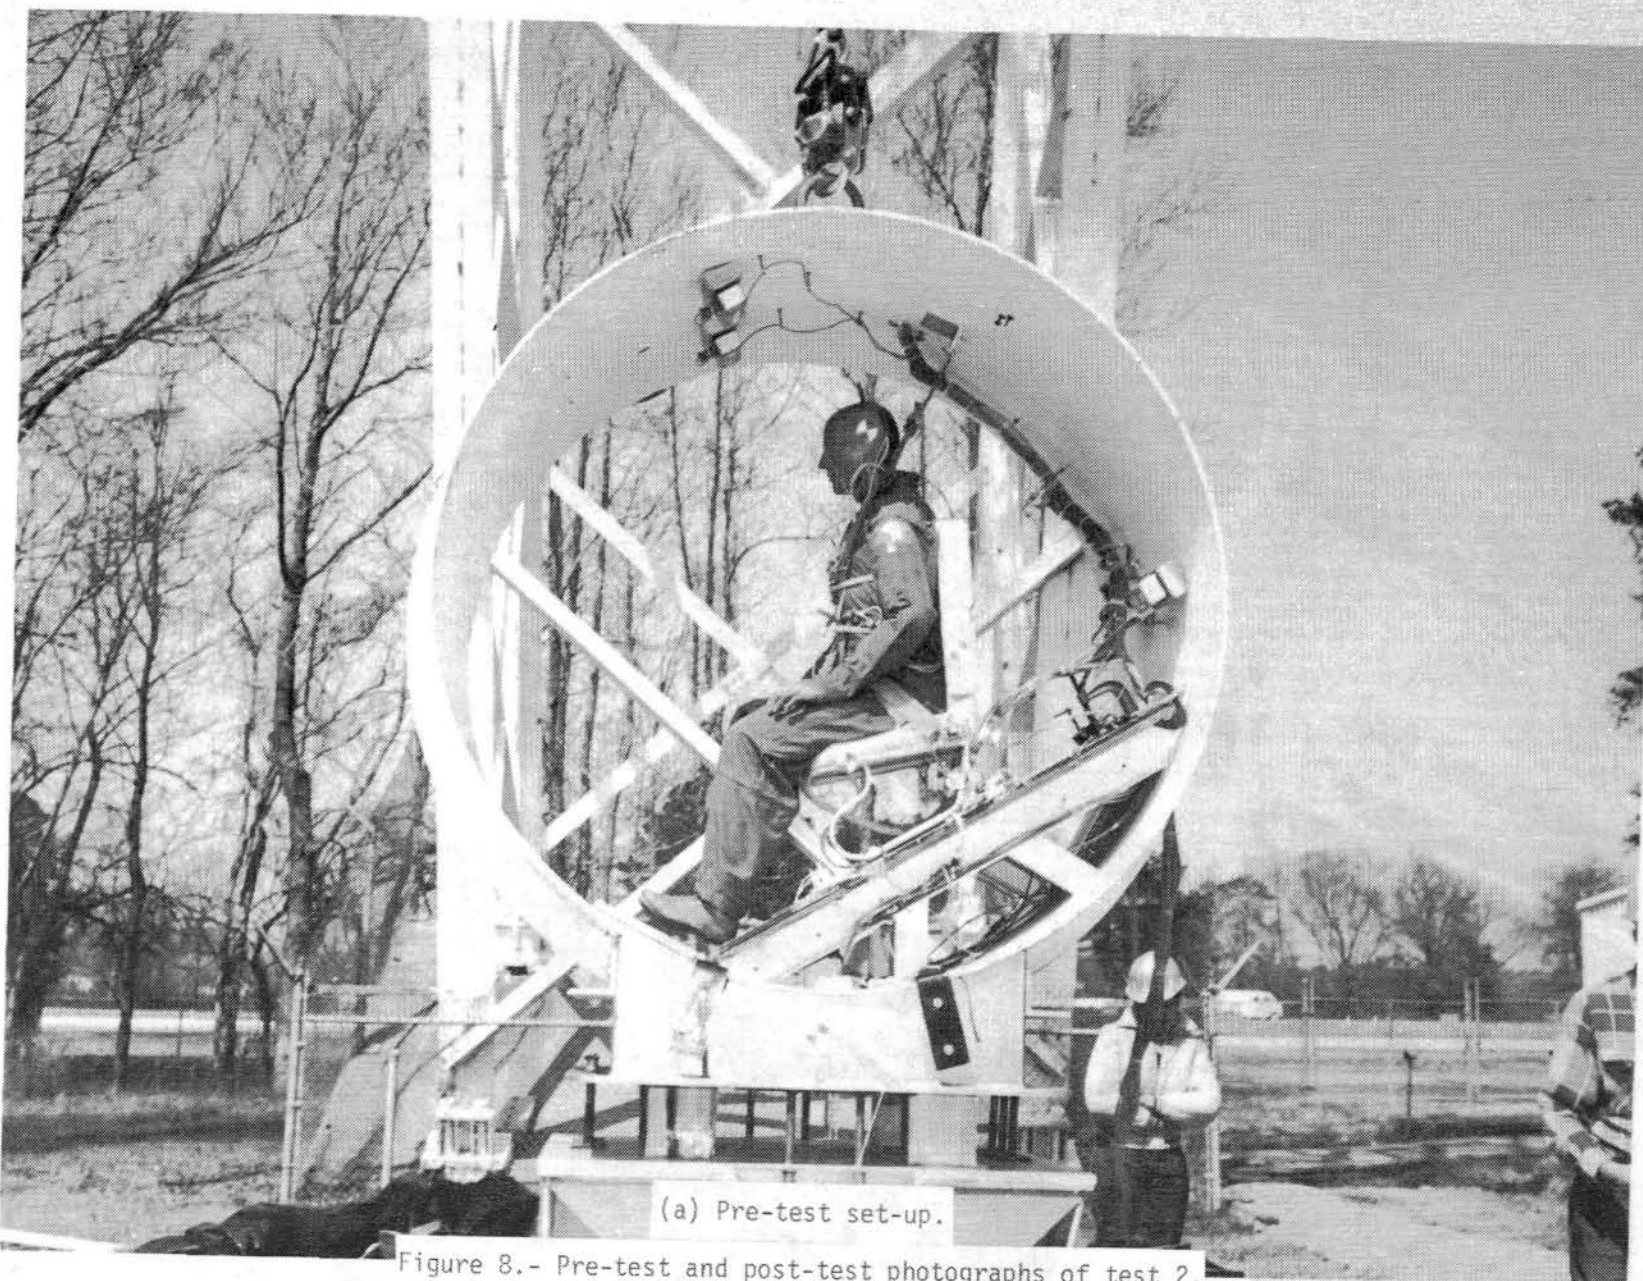
(a) Pre-test set-up.

JAARS Folding Passenger Seat. - Figures 8(a) through 8(c) are pre-test and post-test photographs of the JAARS folding passenger seat for test 2. Figure 8(a) shows the pre-test set-up with the apparatus being readied for the 30° pitch down impact attitude, and figures 8(b) and 8(c) are two views of the seat pan failure which occurred during the test.

JAARS Foam Block Passenger Seat. - Figure 10 presents pre-test and post-test photographs of the JAARS foam block passenger seat for tests 3 and 4. Figures 10(a) and 10(b) show the test set-up (impact position) for the 0° pitch down condition of test 3 and for the 30° pitch down condition of test 4, respectively. Note from the photographs that the dummy's back is more aligned with the vertical input pulse in the 30° pitch down condition (figs. 8(a) and 10(b)) than in the 0° pitch condition, (fig. 10(a)).

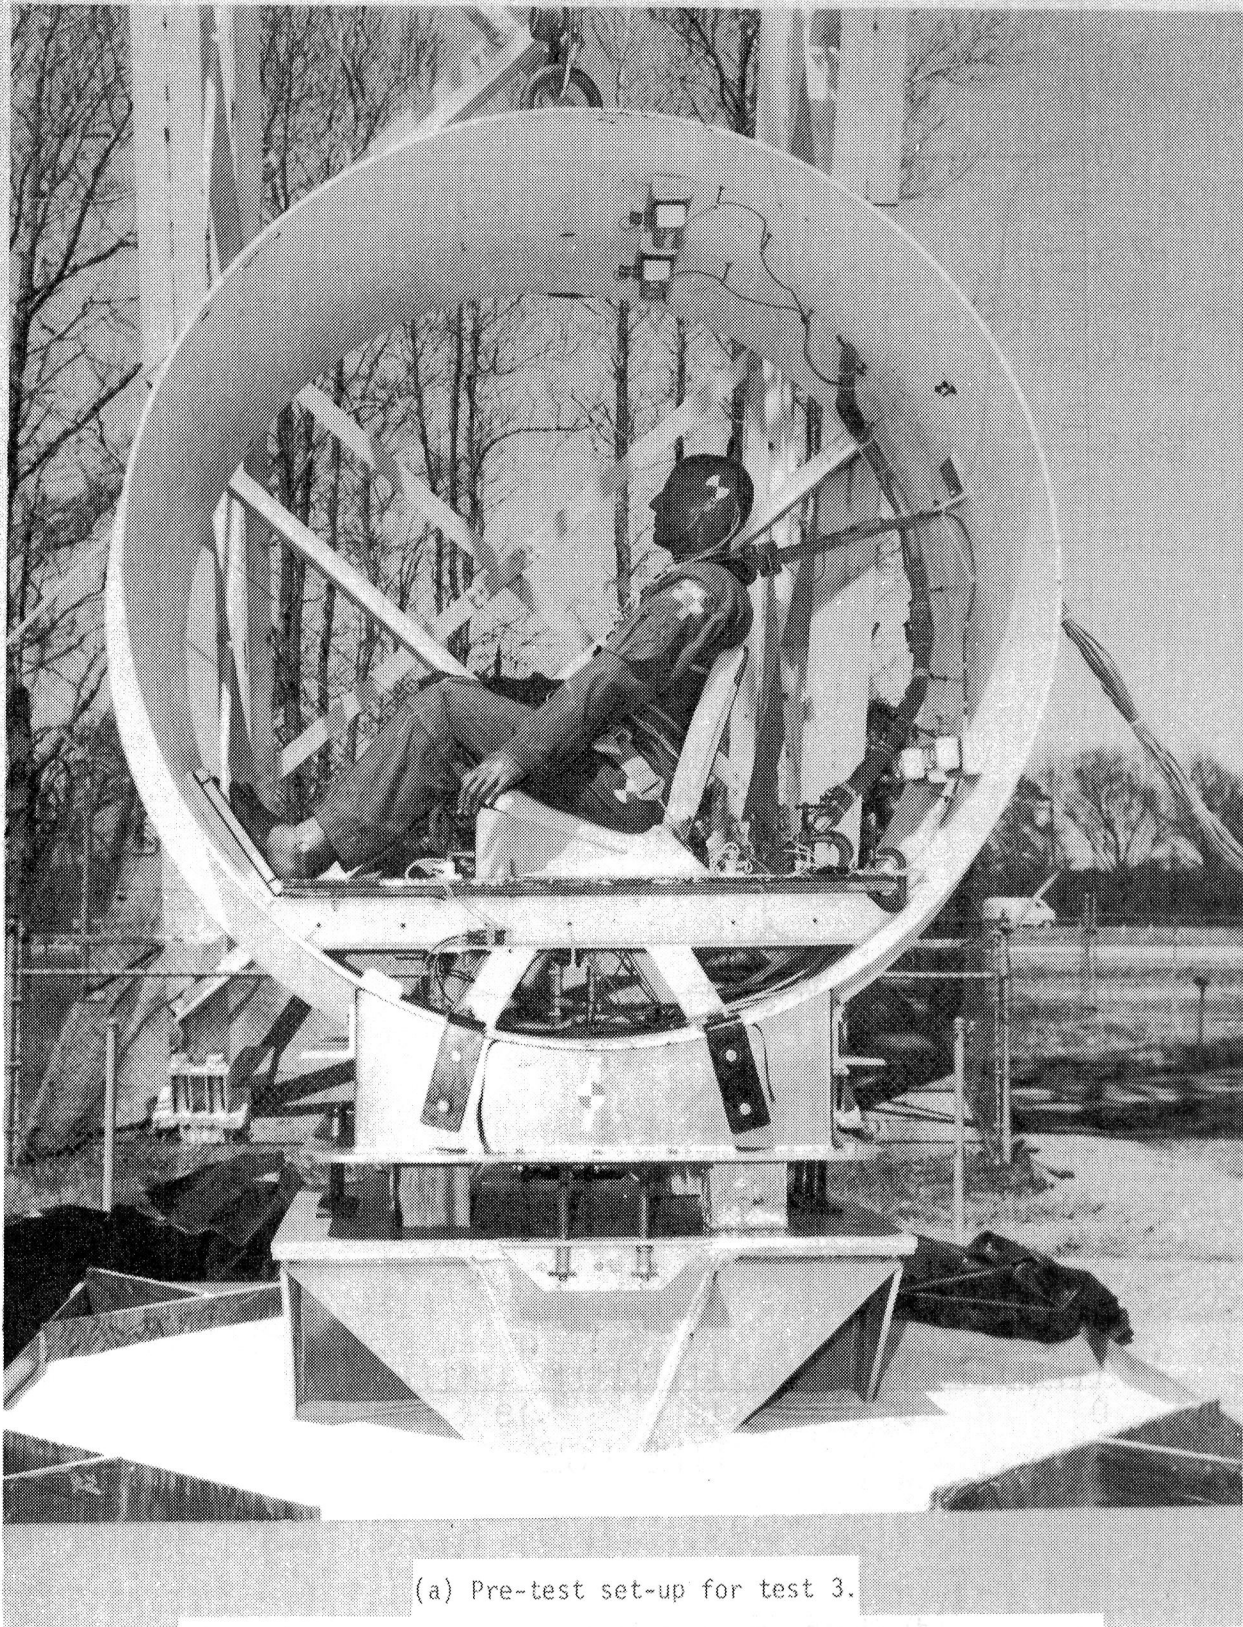
(a) Pre-test set-up for test 3.

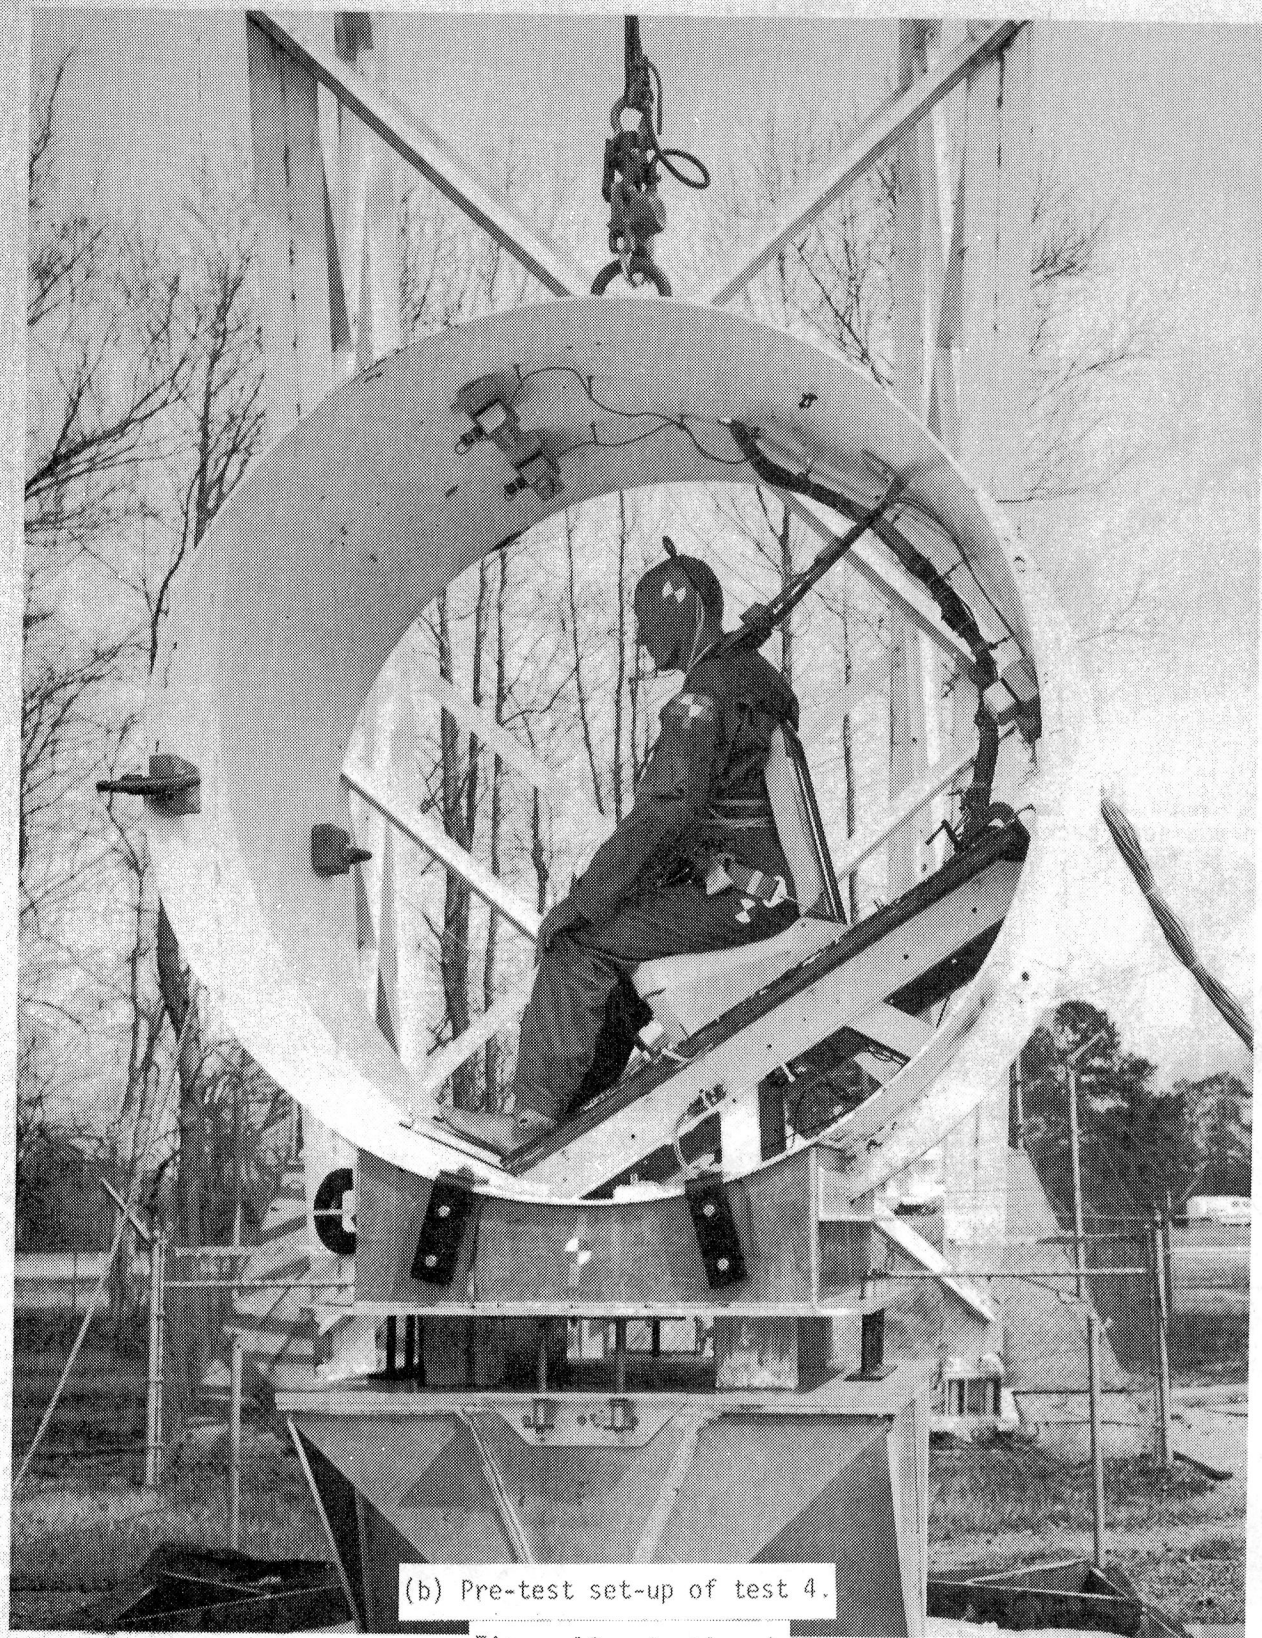
(b) Pre-test set-up of test 4.

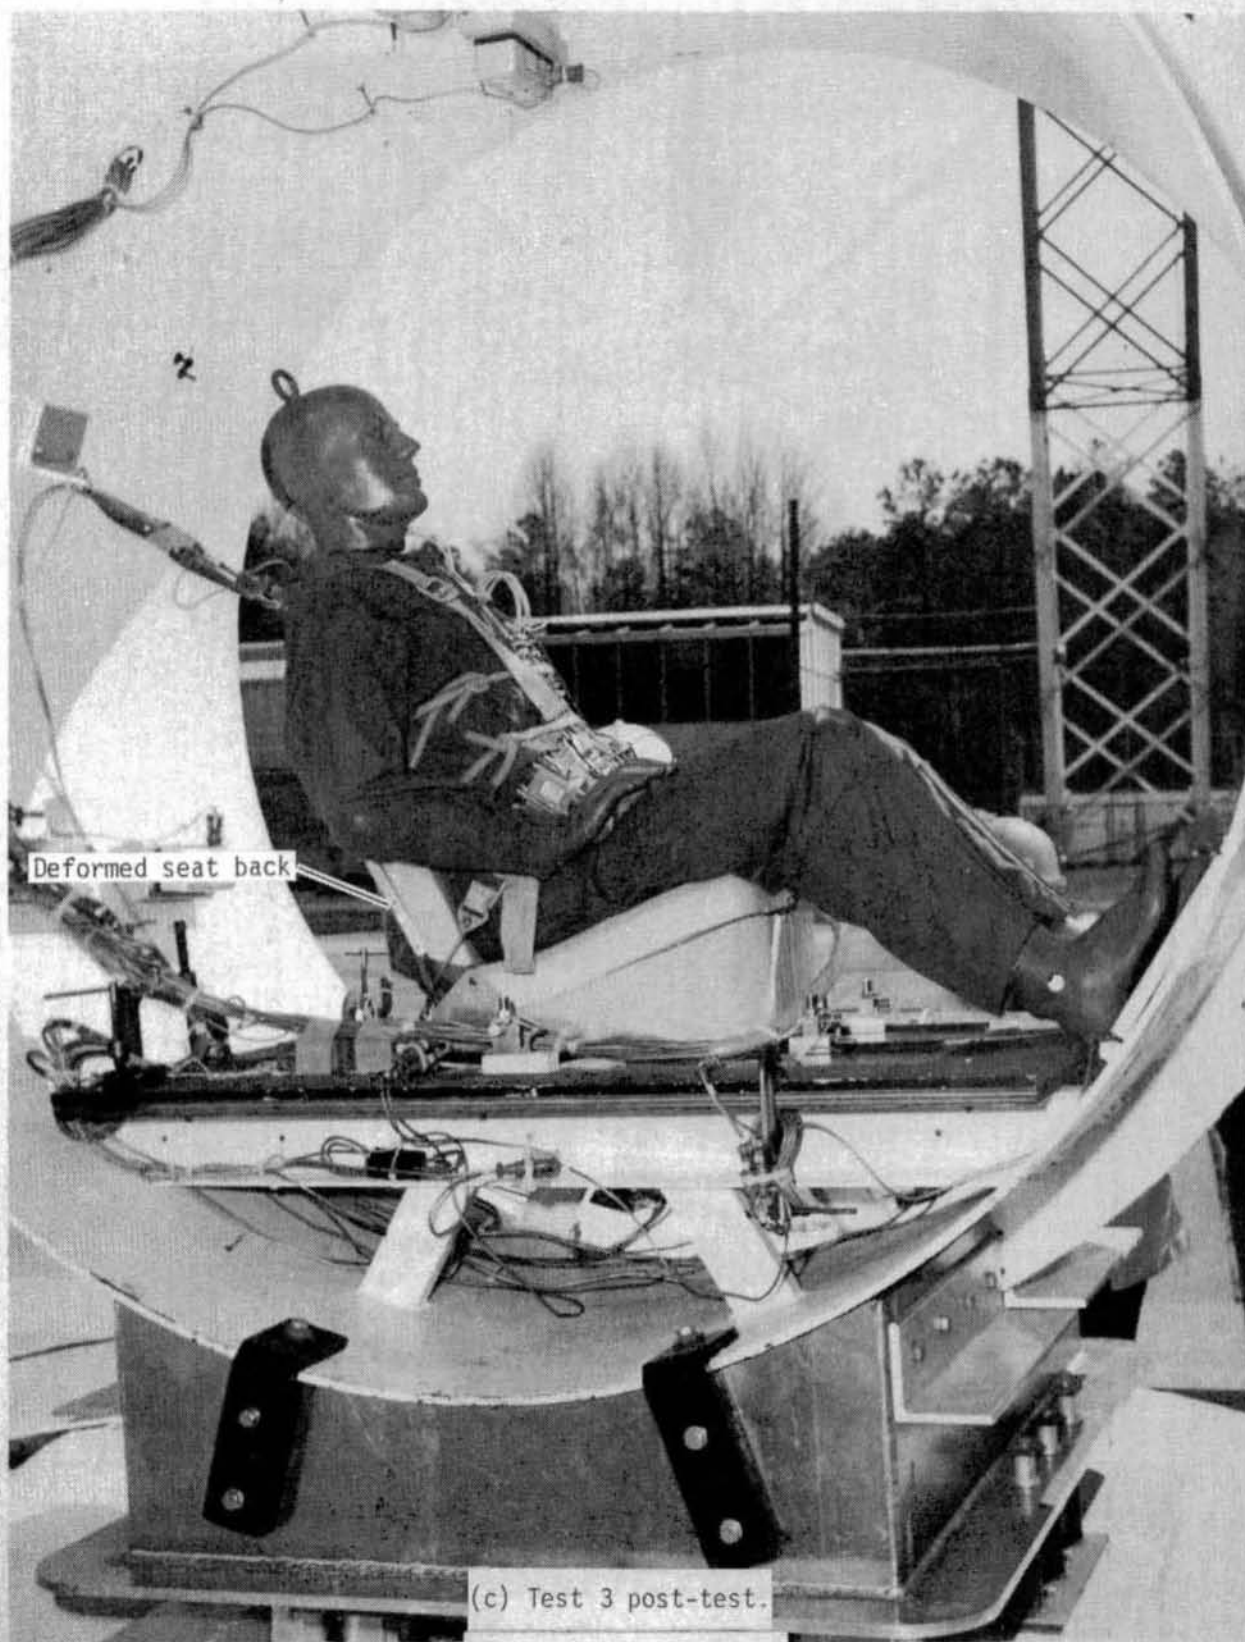
(c) Test 3 post-test.

force, which caused the seat back to plastically deform as the occupant's upper torso rotated backwards (see figure 10(c)). In test 4 the occupant's upper torso pitched forward, loading the restraint system. As seen in figure 10(d), the shoulder harness pulled the lap belt buckle upward, which is undesirable as submarining of the occupant could occur. The lap belt anchor points are too far rearward for this seat. Negligible crushing of the foam wedge occurred in the tests. Post-test inspection revealed that the foam wedge had cracked in the unsupported area beneath the seat (figures 10(e) and 10(f)).

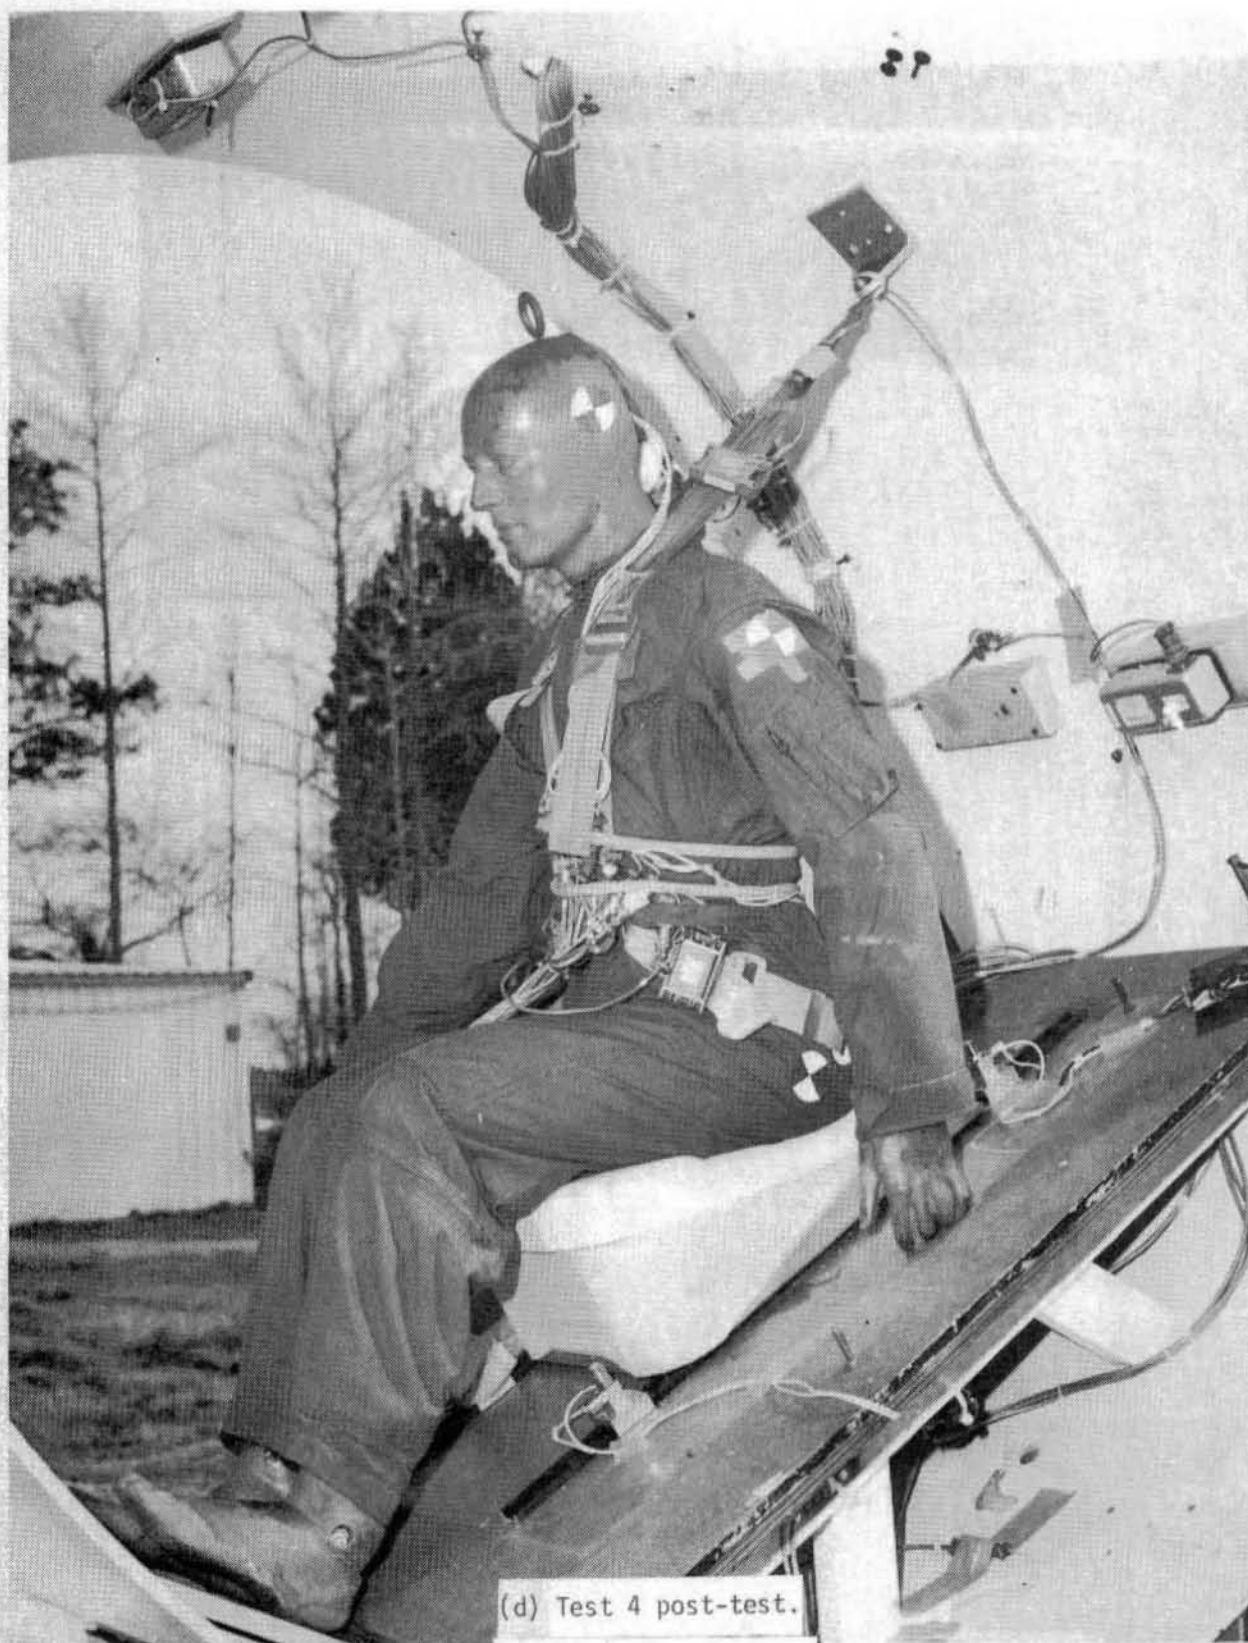
(d) Test 4 post-test.

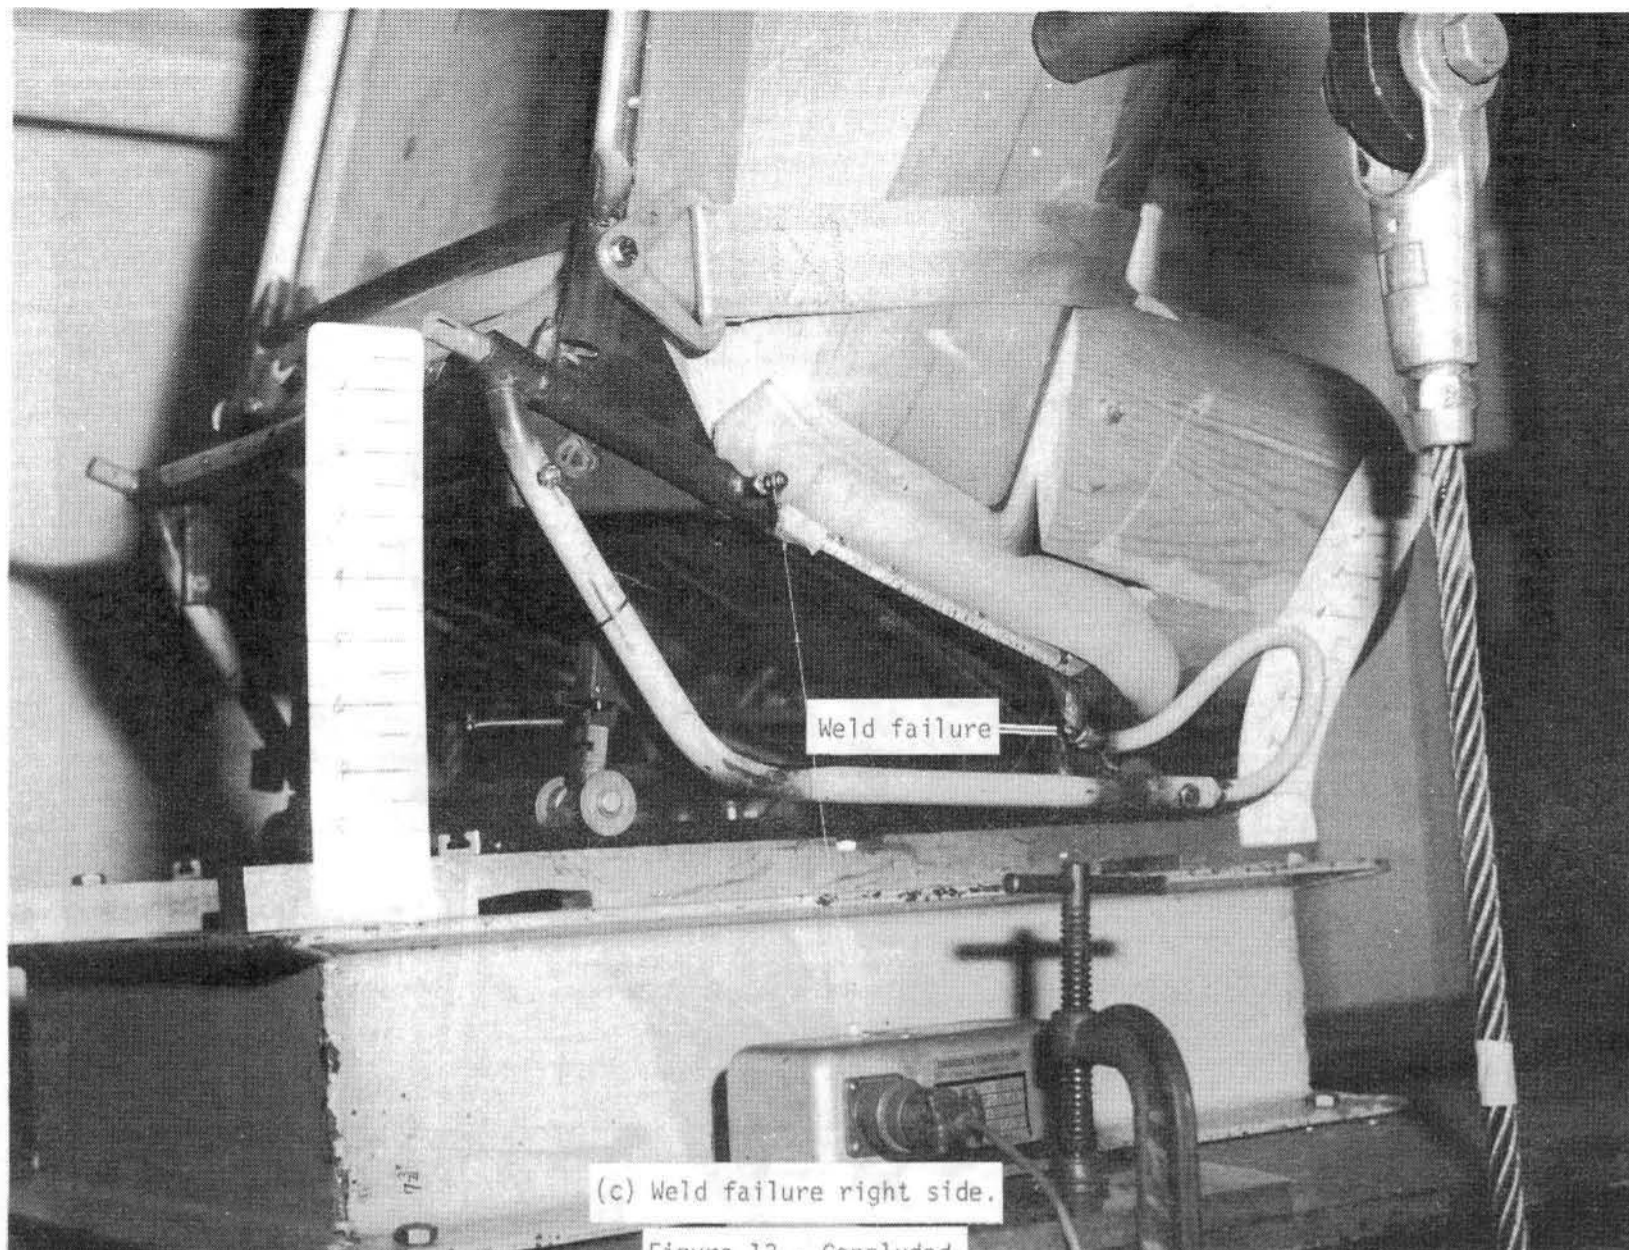
Figure 13.- Crew seat static test.

(b) Weld failure left side.

(c) Weld failure right side.

JAARS Crew Seat. - The JAARS crew seat was tested in the NASA static seat testing apparatus to determine the vertical load at which stroking would occur. The vertical load reached a maximum value of 2640 lbs at which point the front legs began to buckle and then dropped to a minimum of 500 lbs as the legs collapsed (fig. 13(a)). Since this seat had been dynamically tested twice (tests 1 and 5), the load of 2640 lbs may be somewhat low for an untested seat. No stroking of the back legs occurred up to the 6700 lb maximum capability of the test machine. If the angle that the back legs make with the vertical is increased, the back legs will collapse at a lower load. The welds at the junction of the front legs with the seat pan failed as can be seen in figures 13(b) and 13(c).
